SAFETY NOTE n°17-02

POTENTIAL LOOSENING OF THE ACD YOKE SYSTEM

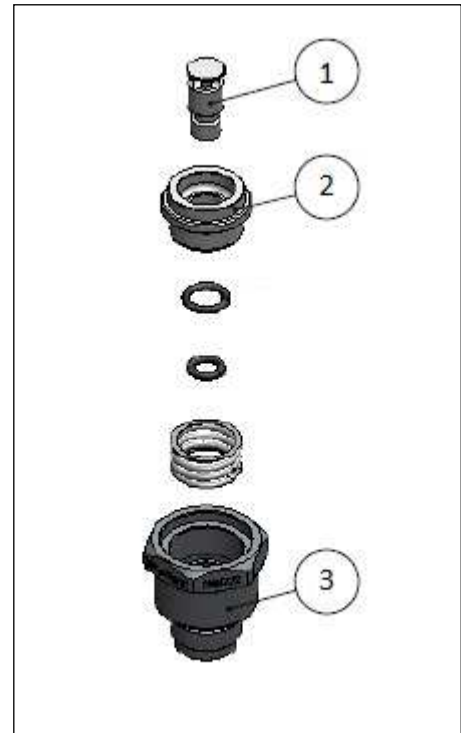
PURPOSE: In ACD yoke systems where the shutter valve (1) has not been properly tightened to the recommended torque, there is a possibility that the shutter valve (1) may loosen itself from the yoke retainer (3). This can happen while trying to remove the first stage from the cylinder while the first stage is still under pressure or while partially pressurized (always make sure the regulator is completely de-pressurized before trying to remove the first stage from a cylinder).

INSPECTION: If the shutter valve (1) is loose, you may see a gap between the shutter crown (2) and the yoke retainer (3).

CORRECTIVE ACTION: If you find a gap in the shutter crown (2) then you will need to remove the yoke retainer (3) from the regulator body and re-torque the shutter valve (1) to 0.3m.Kg (3N.m) following the instructions in the maintenance manual.

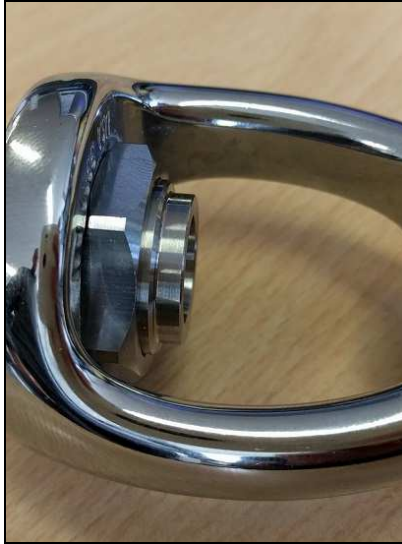
Picture A

Picture (A) shows the correct position and picture (B) shows a loosened shutter valve (1) with a gap. The red mark characterizes the gap.

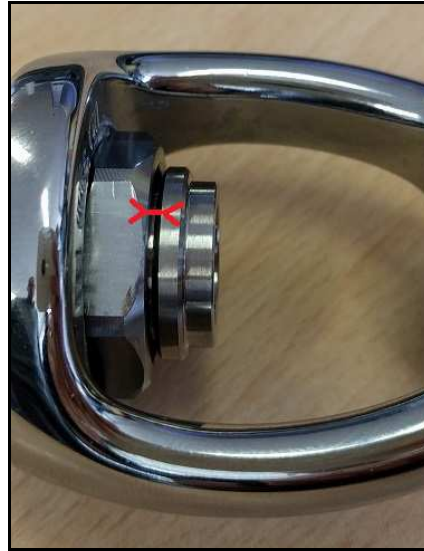
Picture B

When the shutter valve (1) is unscrewed enough, it can disrupt the flow of gas from certain cylinder valves that have a threaded front insert.

WARNING: We draw your attention to the fact that when the shutter valve (1) is unscrewed enough, it disrupts the gas flow. With some valve inserts proposed by the market, whose hex is smaller than 8mm, it can lead to a gas failure underwater.
